USACERL Technical Report FM-93/07

January 1993

Corrosion Mitigation and  
Management System

# Corrosion Assessment of an Army Installation Gas Distribution System Using MicroGPIPER

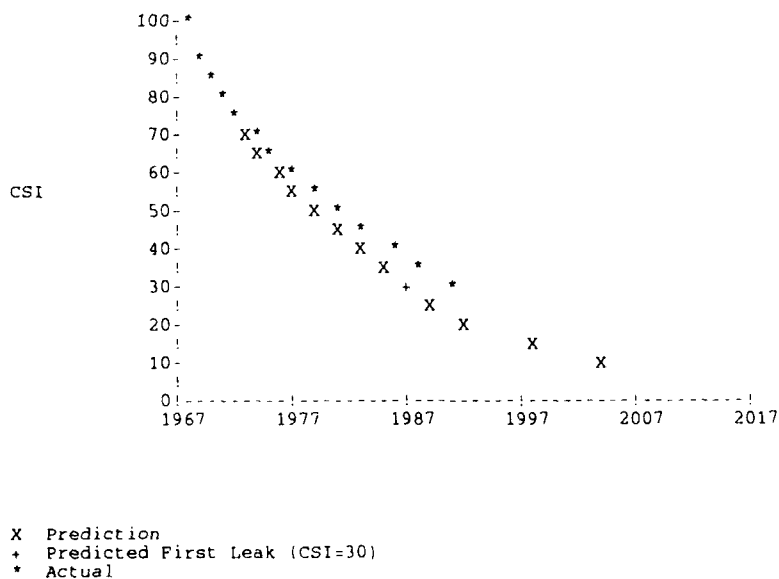
Appendix B contains CSI reports generated for the pipes at each of the soil sampling locations. The GPIPER predictions correlated quite well with the findings of the field survey. GPIPER correctly predicted the severe soil-induced corrosion problems that had been occurring in the family housing area, as well as the leak at Forest and Jackson streets. For example, the plot that was generated from the information taken at Building 5957 (family housing) is shown in Figure 5. GPIPER predicted that pipes under the soil conditions found at Building 5957 should be expected to begin leaking in 1987, and that by 1991, there should be roughly seven leaks per mile of pipe (cumulative). In addition, GPIPER predicted that a leak should have occurred at Forest and Jackson (pipe section FOR&JACKSN 2) streets in 1984. Given the severity of the leak that was observed at that location, it is likely that the leak began long before it was discovered in 1991.

PIPE IDENTIFICATION	: BLDG. 5957	SECTION NUMBER:	1
SOIL RESISTIVITY	: 6006.00	SOIL pH	: 5.60
COATING MATERIAL	: WRAP COAL TAR	WALL THICKNESS:	0.2800
YEAR INSTALLED	: 1968	PIPE SIZE (OD):	6.0
PREDICTED FIRST LEAK (CSI<=30):	1987	ACTUAL FIRST LEAK:	1991.05.14

Figure 5. Corrosion Status Index (CSI) Report for Bldg. 5957 (Family Housing).

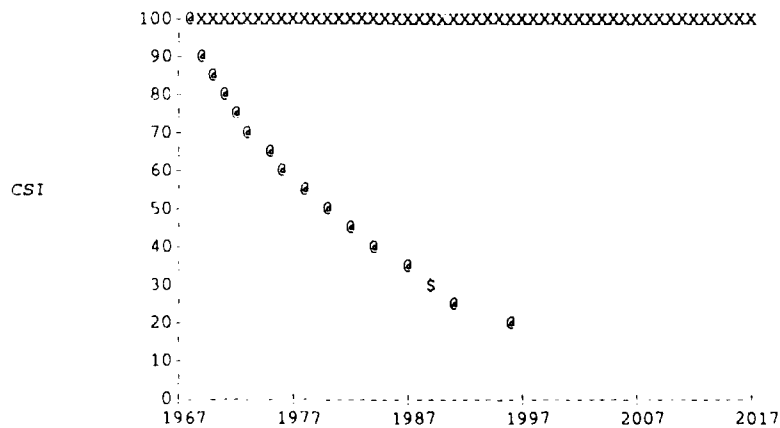
The CSI report for the cathodically protected main at Forest and Jackson (pipe section FOR&JACKSN 3) shown in Figure 6, illustrates clearly that with the use of a properly maintained CP system (straight line comprised of X's on the plot), the CSI should remain at 100 (excellent condition) indefinitely. The other curve on the plot shows what will happen without cathodic protection.

Figure 6. CSI Report for Cathodically Protected Main at Forest and Jackson.

1. Install CP on the unprotected 8- and 10-in. mains, which appear to be in good condition. Perform current requirement and design testing to determine the optimum type of CP on the unprotected mains. Existing CP indicates that magnesium anodes can be used. Additional GPIPER analyses using the procedures described in this report can be used to prioritize sections of the mains for installation of CP, as well as the criticality of CP maintenance after it is installed.
